MRI of the knee, shoulder and ankle

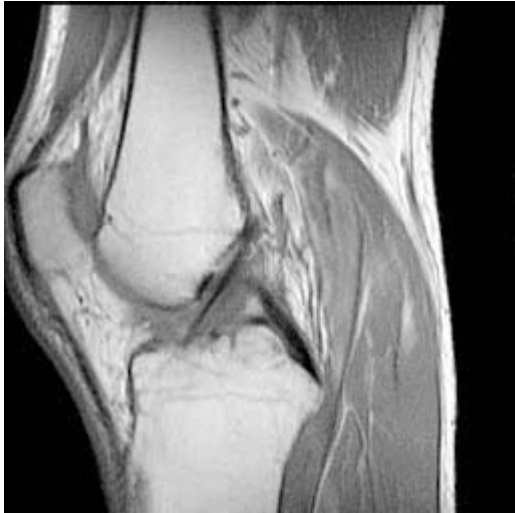
The anterior cruciate ligament is usually not a simple linear band. Instead, it is normally fan shaped, as shown below

The anterior cruciate ligament usually lies in a plane 10 - 15 externally rotated to the sagittal plane. Therefore, if one obtains images in this plane, one can image the ACL in over 95% of the time.

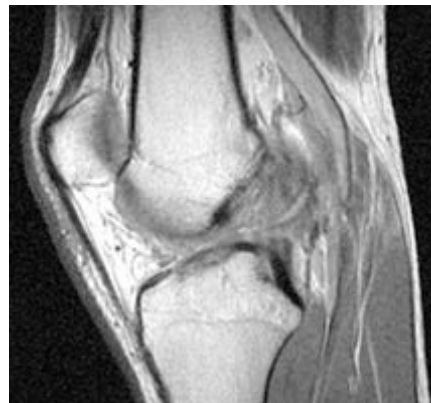
On the following image the anterior cruciate ligament is completely obliterated

- high signal on T2
- wavy contour
- ACL not seen
- ACL discontinuity
- lateral femoral condyle bone bruise

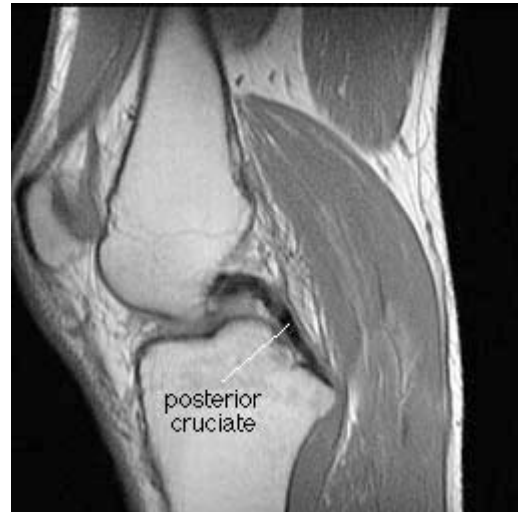
The PCL is twice as strong as the ACL. It contains a larger cross-sectional area and possesses a higher tensile strength, explaining its lower rate of injury. Note the ligament of humphrey that looks like a small dark lump, such as seen below. It may occasionally be seen as separate from the PCL and mimic an intraarticular body.

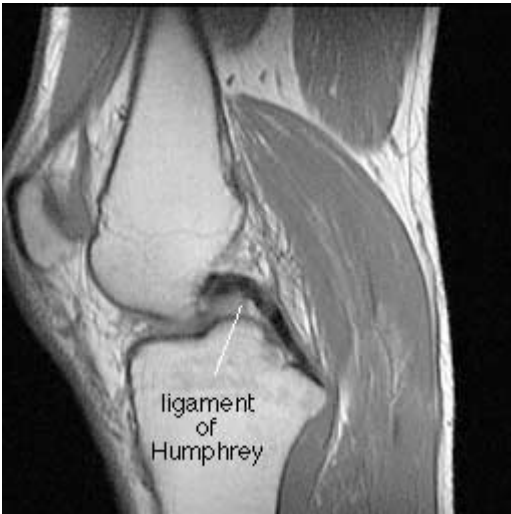
Types of PCL injuries

- Complete tears - Approximately 40%
- Partial tears - Approximately 55%
- Avulsion tears - 7%

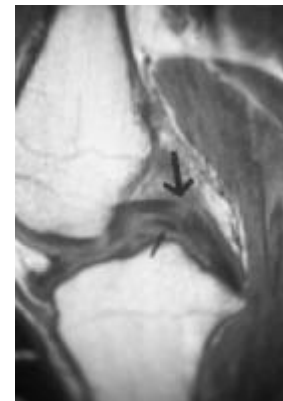
The following is a proton-density-weighted sagittal image that shows an extensive partial tear of the midsubstance of the posterior cruciate ligament (large black arrow). High signal intensity is seen in the region of injury.

The normal ligament of Humphrey (small arrow) is visualized better because it is adjacent to the high signal intensity edema around the torn posterior cruciate ligament

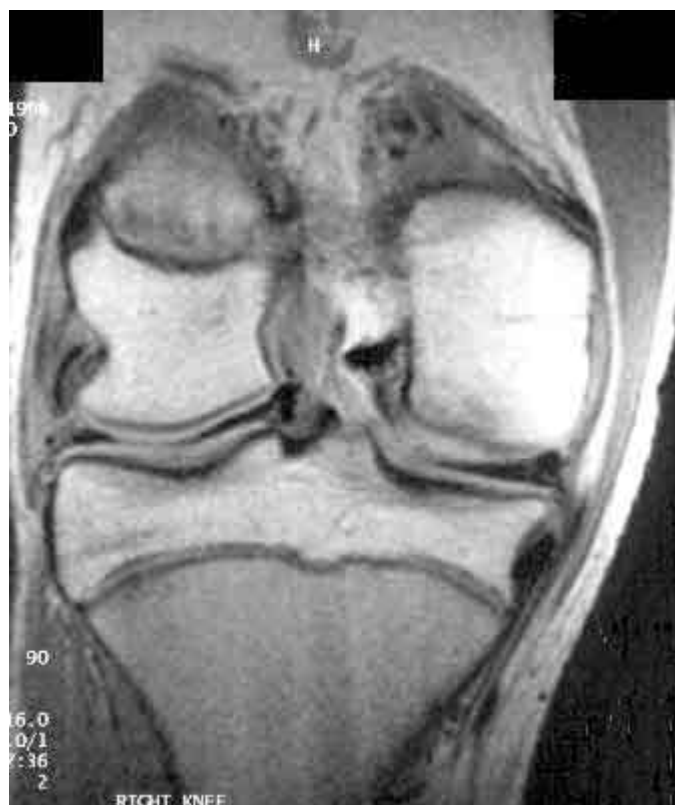
The next images show the meniscii of the right knee:

Menisci normally seen as a bowtie configuration and homogeneously black. Posterior horn of medial meniscus should normally be largest. Lateral meniscus should not be larger or else consider discoid meniscus (prone to tear).

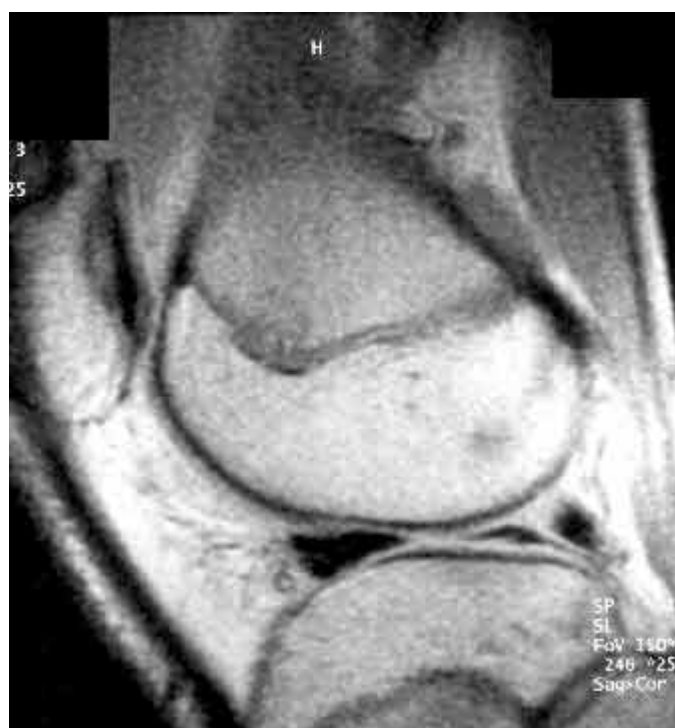
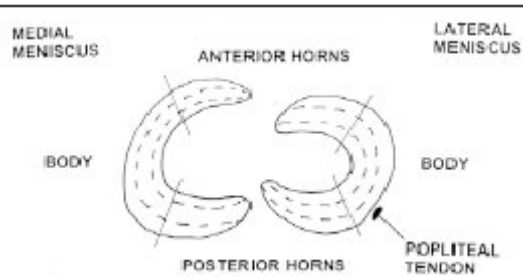
A bucket handle tear is present in the lateral meniscus. The bucket handle tear fragment is displaced anteriorly on the sagittal view

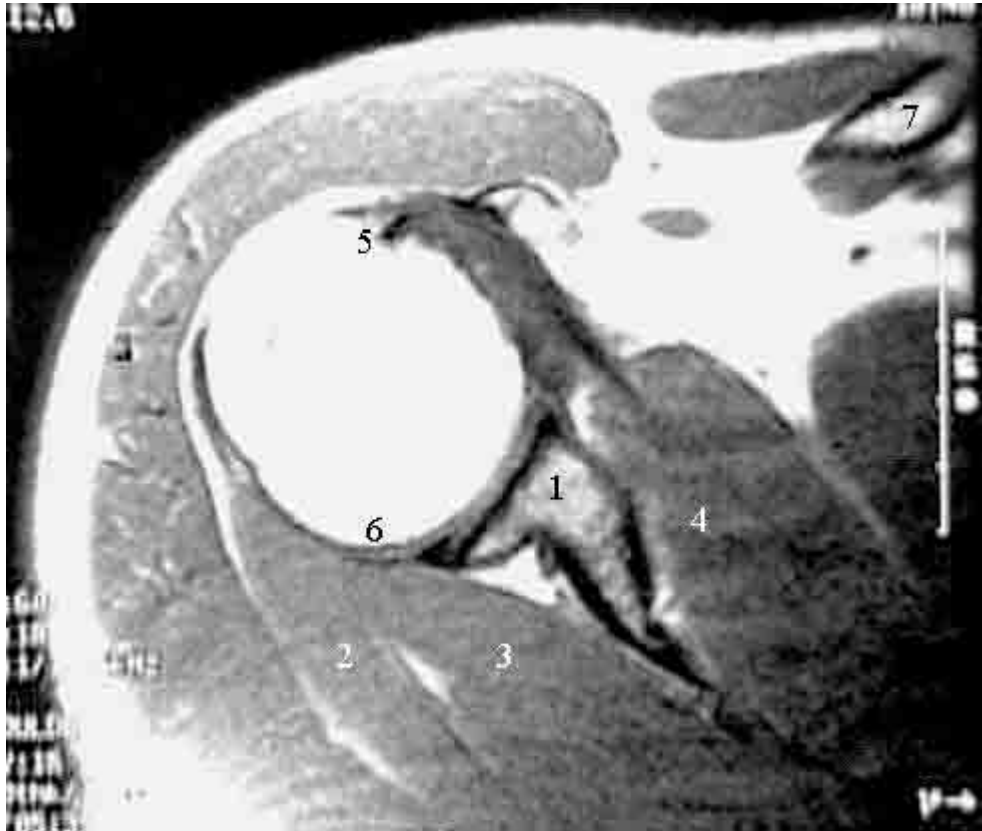
Normal axial anatomy of the shoulder joint

1. Long Head of Triceps
2. Teres Minor Muscle
3. Long Head of Triceps
4. Subscapularis Muscle
5. Tendon of Long Head of Biceps
6. Glenoid labrum.

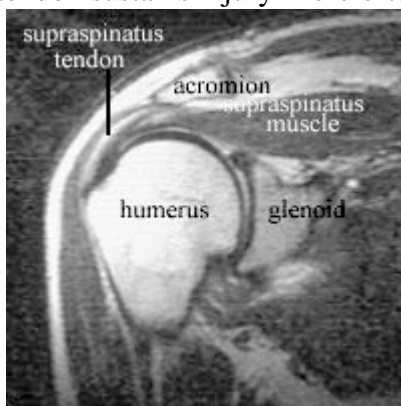
On MRI, rotator cuff tears appear as areas of increased signal in the tendon. Tears can be full thickness or partial. In full thickness tears, the

muscle can pull away from the joint because the tendon no longer anchors it to the humerus. MRI also reveals the extent of impingement on the rotator cuff from the acromioclavicular joint, findings that are important to note when surgical repair is being considered

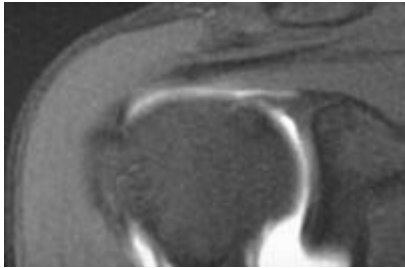
The following sequence was performed following gadolinium injection into the shoulder, T1-weighted with fat suppression. There is no fluid in the subacromial/subdeltoid bursa.

Therefore the supraspinatus tendon must be intact.

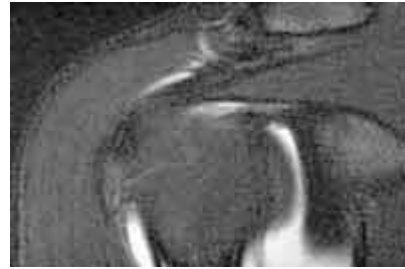
The next image is a fast spin-echo T2-weighted image in the same patient. In this image there is fluid in the subacromial bursa. It's clear that this fluid didn't come from the injection into the joint because it's not visible after the arthrogram.

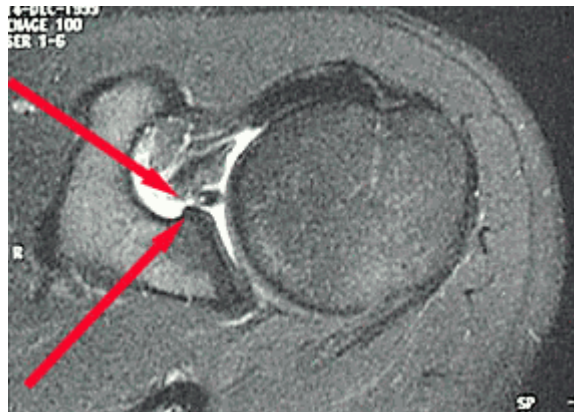
MRI of an Anterior Inferior Labral Tear after a Shoulder Dislocation

When the labrum of the shoulder joint is torn, the stability of the shoulder joint is compromised. A specific type of labral tear is called a Bankhart lesion, and is due to dislocation of the shoulder causing the tear. The Bankhart lesion is located in a specific area of the labrum (anterio-inferior), and makes the shoulder prone to recurrent dislocation.

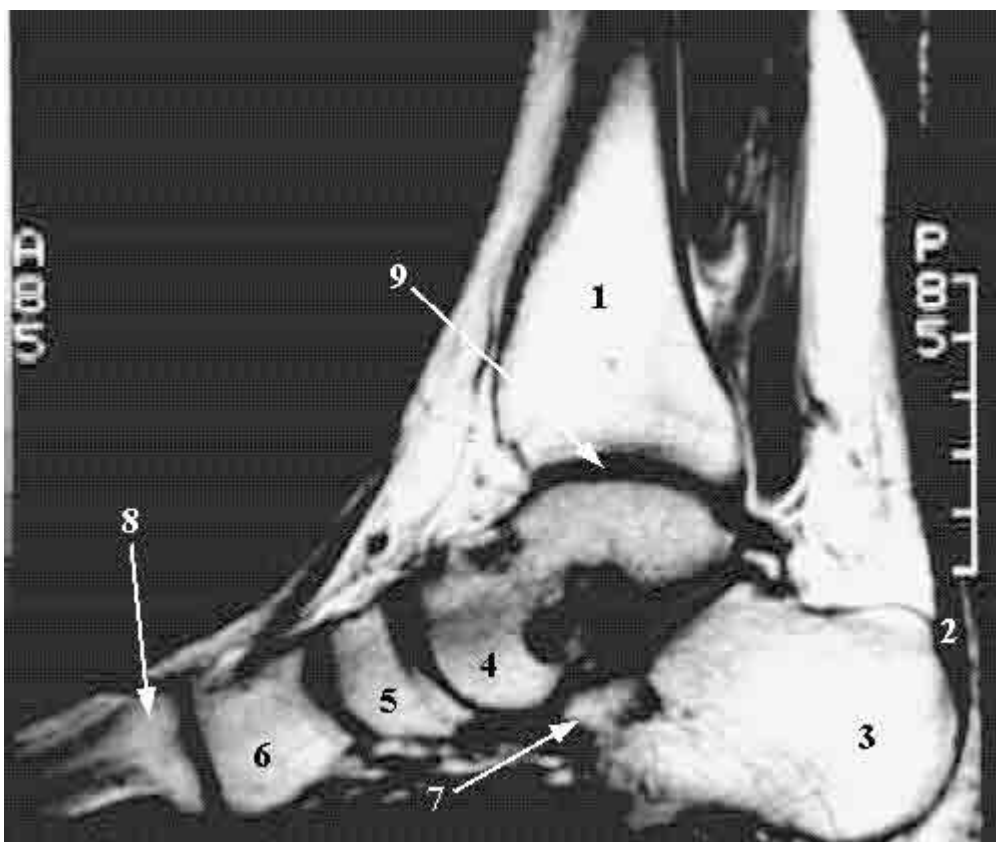
Normal Ankle Anatomy

- 1 Lower end of tibia
- 2. Calcaneal tendon
- 3 Calcaneus
- 4. Talus
- 5. Navicular
- 6. Medial cuneiform
- 7. Sustentaculum tali
- 8. First metatarsal bone
- 9. Talocrural joint (ankle)

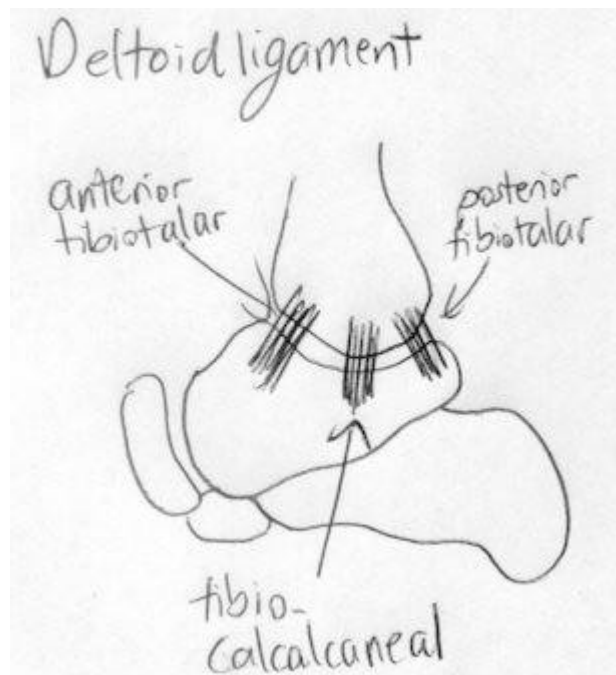
The medial collateral (deltoid) ligament is divided into four parts.

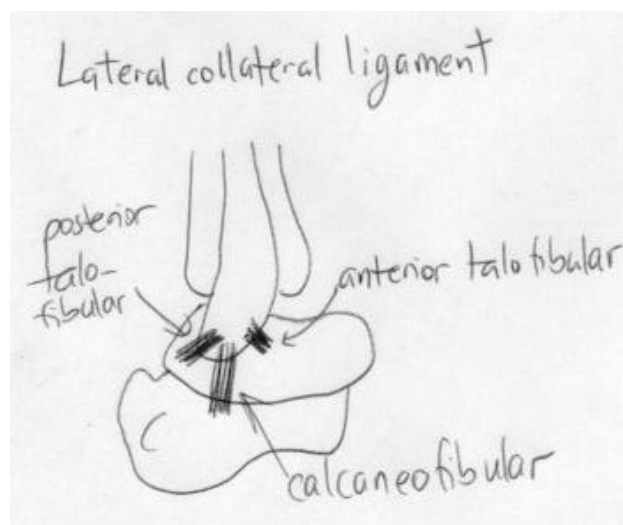
The lateral collateral ligament is made up of three parts as shown below. The anterior talo-fibular ligament is the most frequently injured ankle ligament.

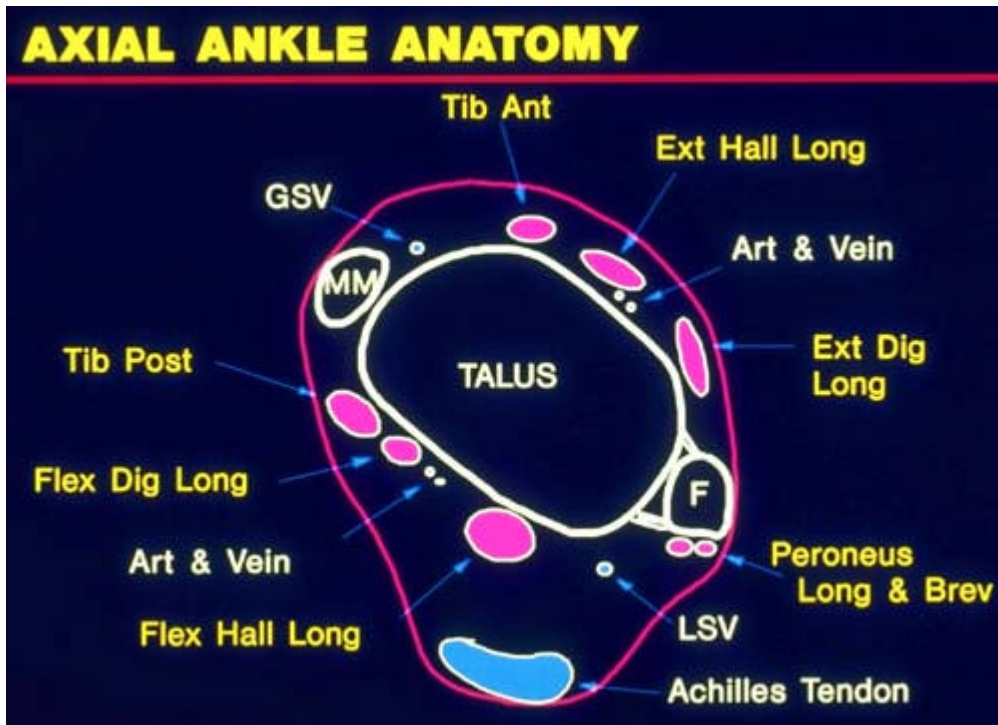
Most injuries only occur in a few areas: the Achilles, the tibialis posterior, the flexor hallucis longus (occasionally), the peroneal tendons (occasionally), and the tibialis anterior (very uncommonly). The following image is an axial T1-weighted image, and can be used to find the aforementioned tendons: the Achilles, peroneus longus and brevis (the brevis often has a small slip of muscle associated with it), the flexor hallucis longus (the muscle of which can be used as a guide for finding the flexor hallucis longus), the sustentaculum talus (just above the flexor hallucis longus, further down in the calcaneal region), and the flexor hallucis.

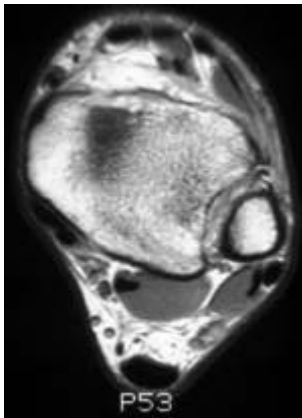
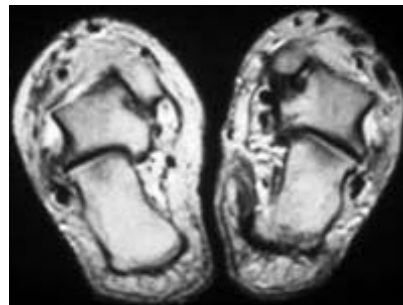
The following image shows an example of a complete tear of the the tibialis posterior. In this T2-weighting the tibialis posterior is present on the left side but is absent on the right. . On the right is an empty tendon sheath, with perhaps one string of fibrous tissue remaining. This scan shows a complete tear of the tibialis posterior.
